HOUSATONIC RIVER BASIN
PITTSFIELD, MASSACHUSETTS

ONOTA LAKE DAM
MA 00016

PHASE 1 INSPECTION REPORT
NATIONAL DAM INSPECTION PROGRAM

NOVEMBER 1978

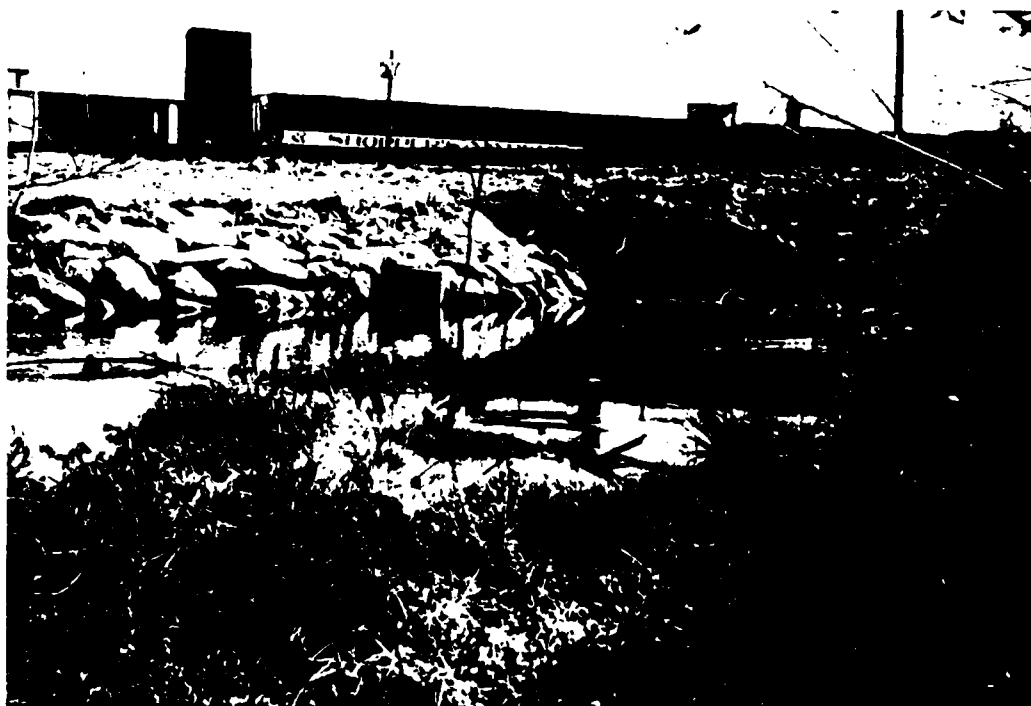
9a. AT INLET. NOTE RIPRAP SLOPE.

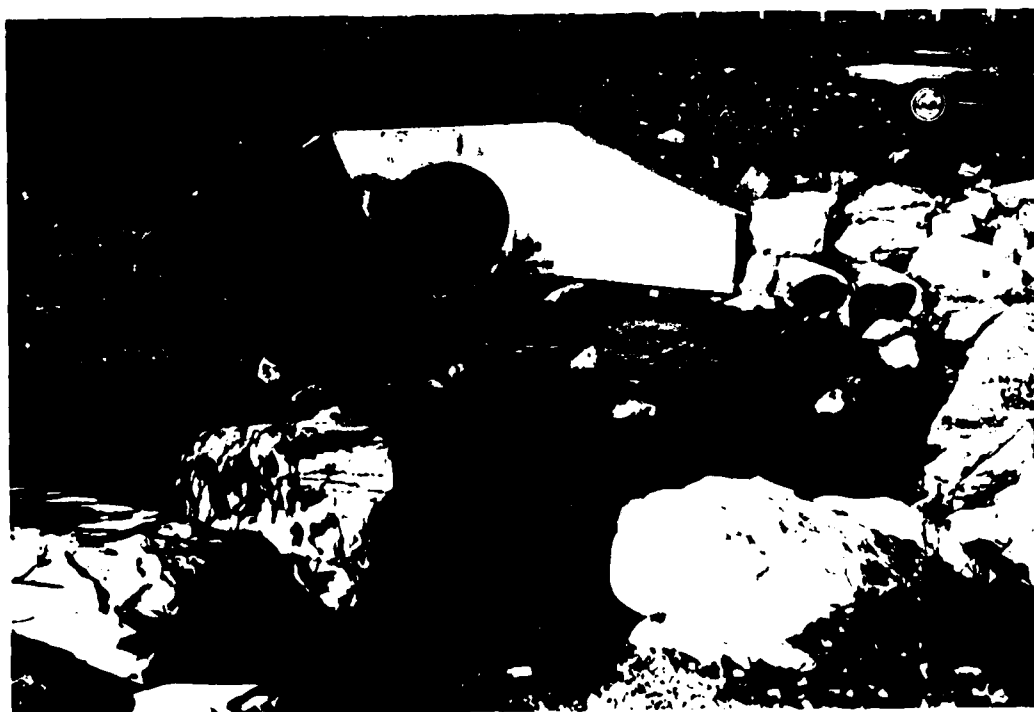
9b. AT OUTLET. NOTE INTAKE STEEL PIPE CONTINUATION OF
UPSTREAM CHANNEL.

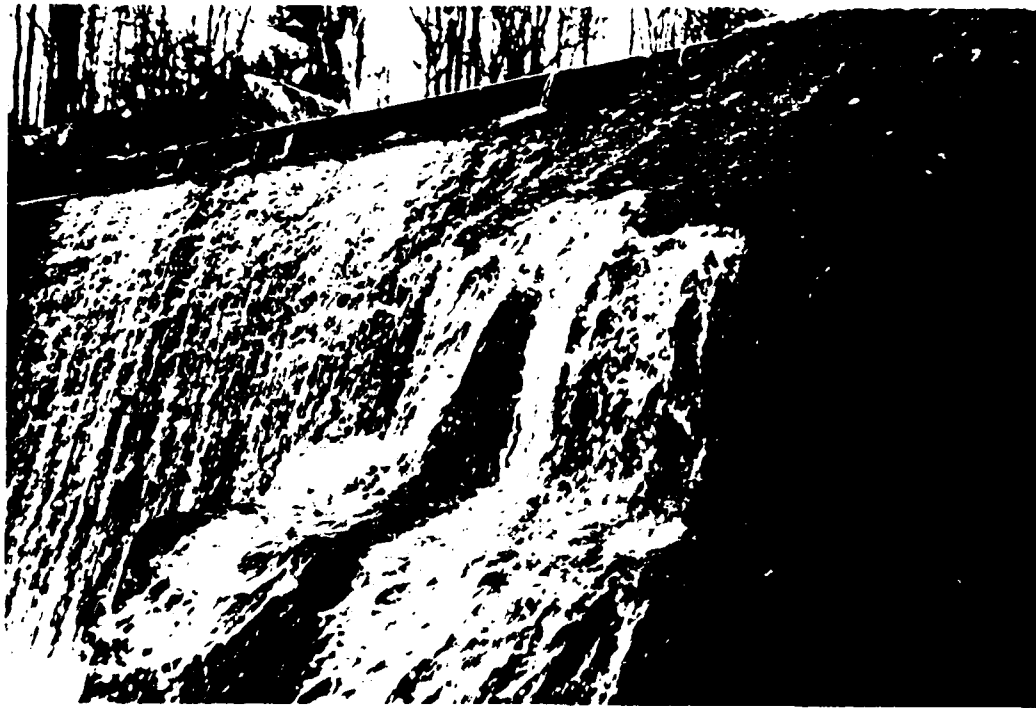
3) The grout on the face of the buttress is spalled and the grout and concrete at the base of the buttress is eroded exposing the underlying stone masonry.

16. VIEW OF SPALLED CONCRETE ON MAIN DAM BUTTRESS.

5. Repair all gunited and concrete surfaces.
6. Keep vegetation in a close cut condition on the crest and slopes of the earthfill portion of the Canal Dam and the area adjacent to the downstream toe.
